Bureau of Mines Report of Investigations/1983

**Report of Investigations 8823**

# **Resistance of Selected Refractories to Mineral Waste Melts**

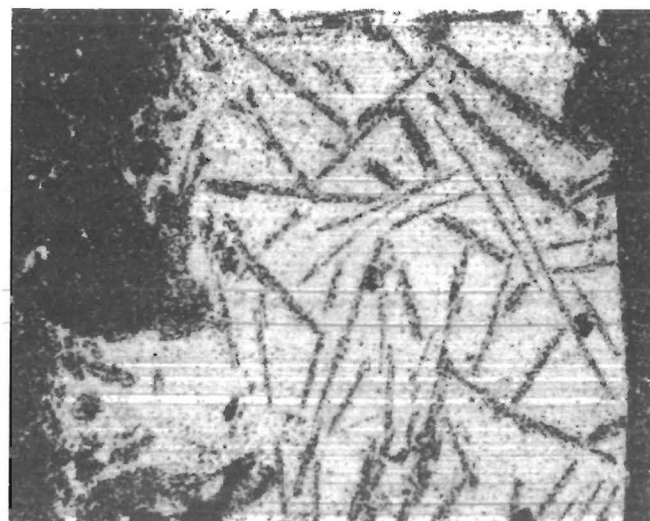
FIGURE 11. - Scanning electron micrographs of elemental distributions at slag-refractory interface, sample B-3.

The micrographs of the basic refractory-slag interface (fig. 11, refractory B-3) clearly show that the extent of Ca diffusion and, thus, slag penetration was slight. The micrographs of this chrome-containing basic refractory indicate that the periclase grains dissolved more readily than the chrome ore grains, which remained as projections

at the refractory-slag interface. The micrographs also show the existence of elongated crystals in the frozen slag layer. The elemental distribution scans indicated that these crystals were high in Mg and Ca, and X-ray diffraction indicated the presence of diopside ( $\text{CaO} \cdot \text{MgO} \cdot 2\text{SiO}_2$ ).
